Contract #: 04-0120F4Cty: SF/ALA Rte: 80 PM: 13.2/13.9File #: 69.28**WELDING INSPECTION REPORT****Resident Engineer:**Pursell, Gary**Address:** 333 Burma Road**City:** Oakland, CA 94607**Report No:** WIR-003281**Date Inspected:** 01-Jul-2008**Project Name:** SAS Superstructure**OSM Arrival Time:** 1400**Prime Contractor:** American Bridge/Fluor Enterprises, a JV**OSM Departure Time:** 2330**Contractor:** Zhenhua Port Machinery Company, Ltd (ZPMC), Changxing Island **Location:** Shanghai, China**CWI Name:** Sun Wei/Li Yanhua**CWI Present:** Yes No**Inspected CWI report:** Yes No N/A**Rod Oven in Use:** Yes No N/A**Electrode to specification:** Yes No N/A**Weld Procedures Followed:** Yes No N/A**Qualified Welders:** Yes No N/A**Verified Joint Fit-up:** Yes No N/A**Approved Drawings:** Yes No N/A**Approved WPS:** Yes No N/A**Delayed / Cancelled:** Yes No N/A**Bridge No:** 34-0006**Component:** OBG**Summary of Items Observed:**

WELDING INSPECTION REPORT

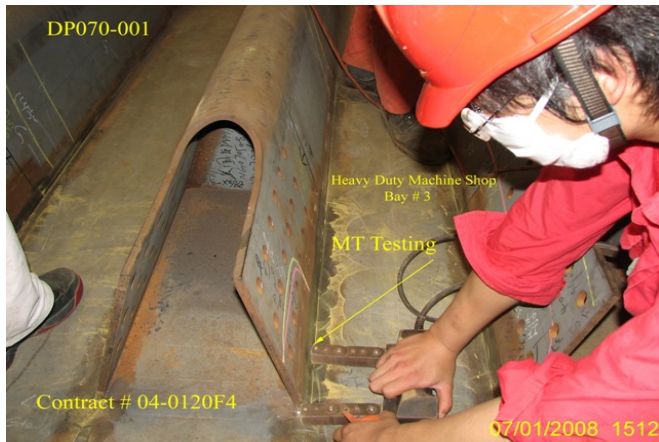
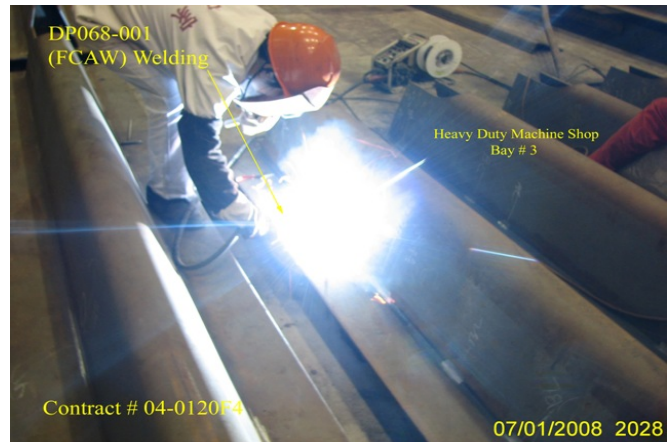
The welding in progress and final visual inspections performed on the above listed deck panels generally appeared to conform to contract specifications.

The deck panel repairs and welding in the progress generally appeared to conform to contract specifications.
